International workshop on conservation and management of Taroko National Park, Taiwan

Article and photos by Deanna Greco

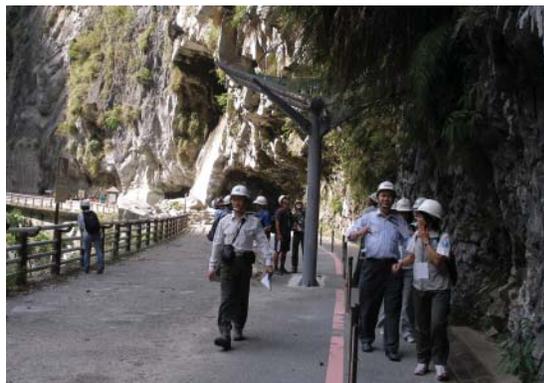
Figure 2 (right). Hard hats and rockfall reduction canopy on Tunnel of Nine Turns Trail.

the likelihood and potential for injuries and even fatalities. The park has installed several protective canopies, and a policy of encouraging hard hat use by visitors provides some defense against small rockfall-related injuries (see fig. 2). However, for any rock larger than a golf ball, these measures only marginally provide any real protection and could actually be a detriment since visitors may develop a false sense of safety and tend to pay less attention to their surroundings.

We consolidated our recommendations for all three sites in a report of findings and suggestions for mitigation and restoration. For the Tunnel of the Nine Turns and Swallow Grotto, both of which have very similar hazards, the prudent approach outside of developing costly engineering solutions would be to reduce the number of visitors using the trails. The sheer volume of visitation, coupled with the rockfall hazard, presents odds that injuries and fatalities will continue to be an issue for the park. Additional efforts at implementing a better transportation system, conducting educational outreach on geologic hazards and the need for restricted access, along with a more controlled trail experience, would help decrease the hazard.

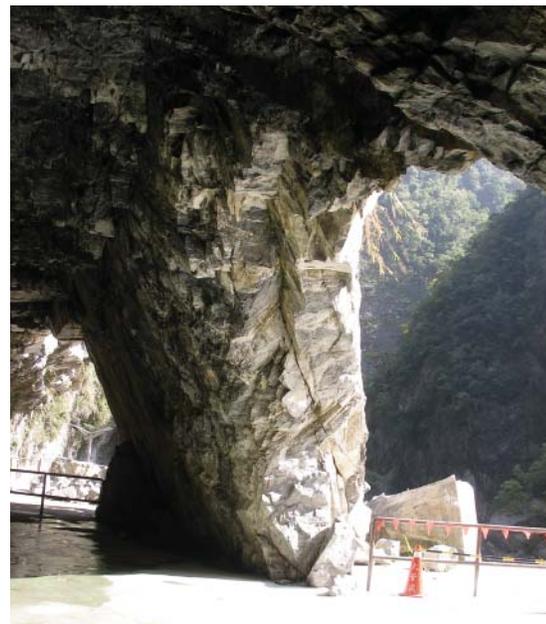
Figure 3 (far right). Large fracture in pillar at west entrance of Tunnel of Nine Turns.

During inspection of the Tunnel of Nine Turns we noticed faults, joints, and folds in the marble, indicating that the rock is inherently unstable. The rock in the tunnel is highly fractured, and continued rock failures are noticeable from the scattered rock fragments on the trail surface. We also witnessed seepage, which can be an indicator of weak points in the rock. At the western bus drop-off location, a large fracture in the asphalt shows potential for slope failure. Additionally, a big fracture in the support pillar at the beginning of the tunnel shows signs of imminent collapse (fig. 3).

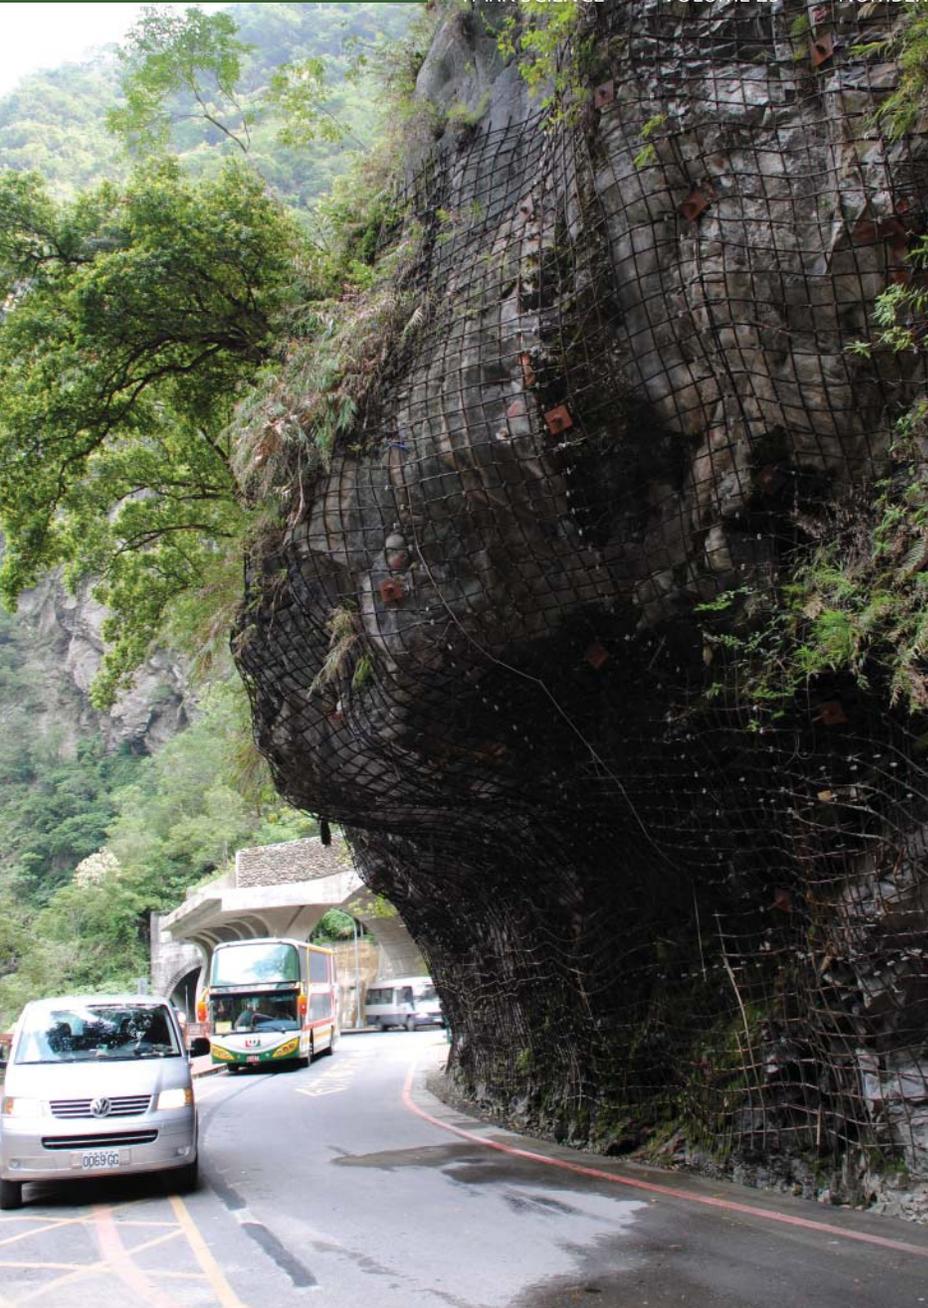
Figure 4. Rock bolts and metal netting at Swallow Grotto west entrance.

Though the hazard is less severe than that of the Tunnel of Nine Turns, the geologic setting of this trail is quite similar, with exposed joints and folds in the rock and fractured marble. Rocks have pitted and marred the asphalt surface here. The park has responded with standard engineering solutions, but unfortunately these have been ineffective. For example, the metal netting installed with rock bolts at the entrance of the trail is insufficient to prevent rockfall from landing on the roadway (fig. 4).

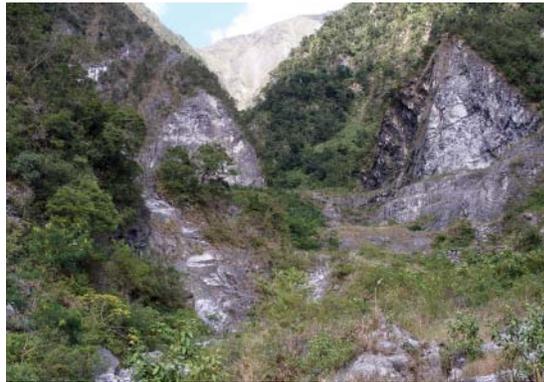
The last area we investigated was a large quarry complex developed by an Australian company for concrete aggregate (fig. 5). The road leading up to the quarry follows a steep mountain creek and has developed gullies about a foot deep. According to park staff the creek was much smaller before the quarry was developed. The increased runoff caused by the road and the quarry has amplified the rate of erosion, down-cutting and widening the creek. The road also has acted as a pathway for nonnative plant infestations in the watershed, with numerous species growing along this corridor.

The quarry walls are terraced and average approximately 30 feet tall, with the upper wall reaching a height of about 50 feet. These walls are fairly stable with the exception of those on the northern side, which are highly fractured, weathered, and most prone to failure. The lower quarry area was once the main processing site. Piles of crushed rock are still present and this site bisects the upper drainage of the creek. The steep slopes have led to massive erosion features emerging from the lower processing area down the hillside and onto the old roadbed.

Figure 5. High walls of the quarry, looking to the east.

Despite the multitude of afflictions owing to Mother Nature at Taroko National Park, the quarry is relatively safe from a geologic perspective. The site has great restoration potential; however, full restoration to natural contours would be very expensive. Additionally, actions required for full restoration would denude the site of its current vegetation and could potentially increase sediment yields in the watershed until large woody vegetation could stabilize the area. Though we provided a range of alternatives, the simplest solution would be the installation of erosion control measures such as stair-step structures and rolling dips at the old processing site to help reduce surface runoff and increase sediment capture.

The simplest solution also presents an opportunity: convert the old quarry road into a loop trail and provide a picnic area. The lower quarry area provides spectacular views of the Pacific Ocean. Making the
